Manhole Inspection Summary

Manhole # S39II_010MH

Insp Date: **3/6/08 10:20 AM**

Location Address: **1700 HOLBROOK ST**

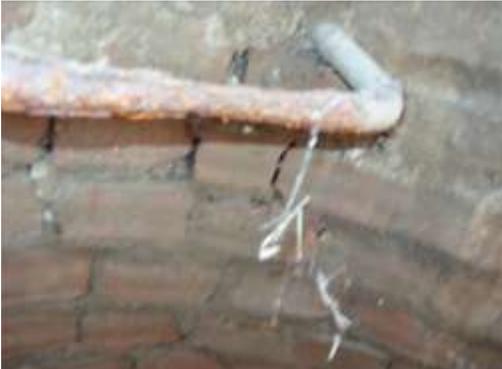
Defect 2

Condition: Sound **Cracked** Root Intrusion Loose Brick Deteriorated

CRACKED BARREL

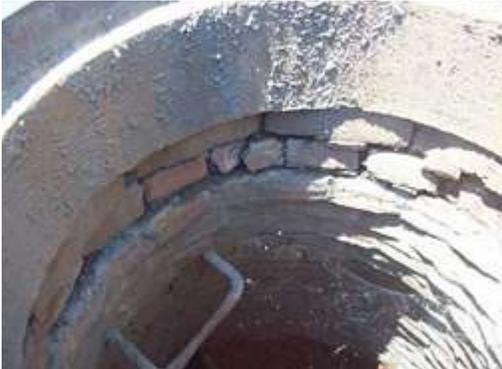
Defect 1

Condition: Sound **Cracked** Root Intrusion Loose Brick Deteriorated

CRACKED CHIMNEY

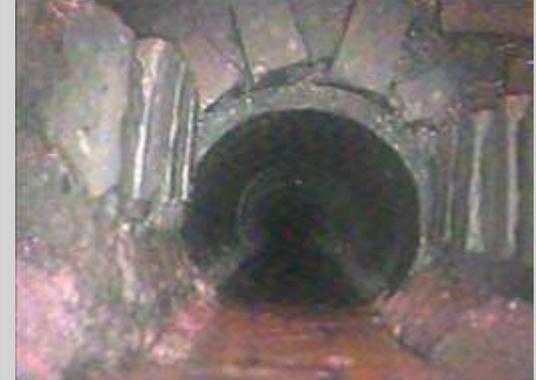
12 O'Clock Outflow

Pipe Height: (in.) Direct
Pipe Material: **Clay** Pipe Lined
Invert Depth: **11.94** (ft.) Flow Characteristics: **Slow**
Deposits: None Mud Sludge Debris Grease
Silt Depth: (in.) Deposits Extent:
Infiltration: **None** Pipe Seal Cond: **Sound**

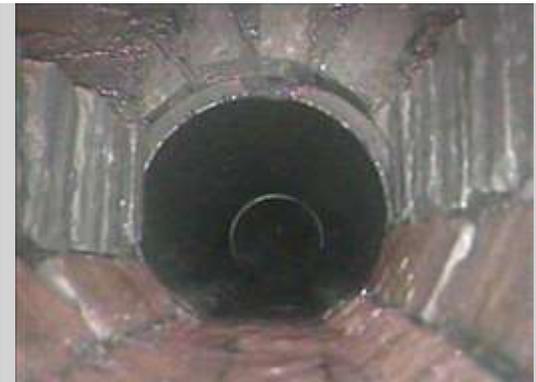
6 O'Clock Inflow

Pipe Height: (in.) Direct
Pipe Material: **Clay** Pipe Lined
Invert Depth: **11.91** (ft.) Flow Characteristics: **Slow**
Deposits: None Mud Sludge Debris Grease
Silt Depth: (in.) Deposits Extent:
Infiltration: **None** Pipe Seal Cond: **Sound**

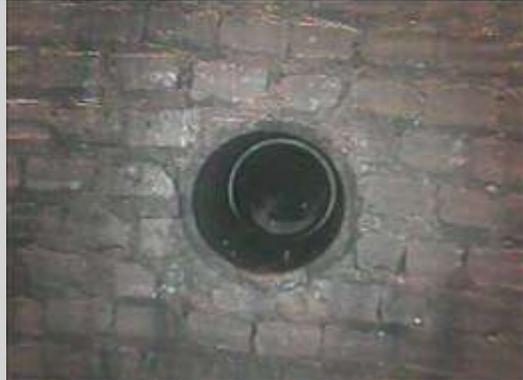
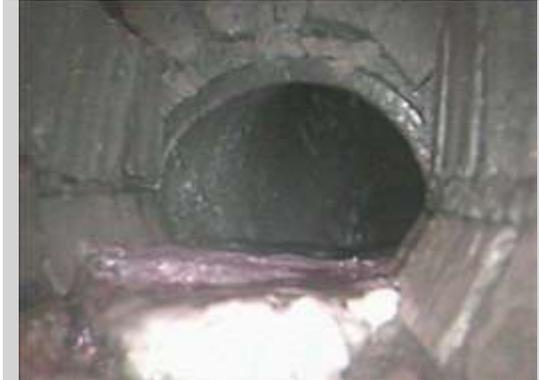
9 O'Clock Inflow

CRACKED CHIMNEY

Drop: **Outside Direct**

Drop Condition: **Open**
